Pre-Purchase Building Inspection Report

Rotaru Building Consultants

Timber Pest Inspection Report

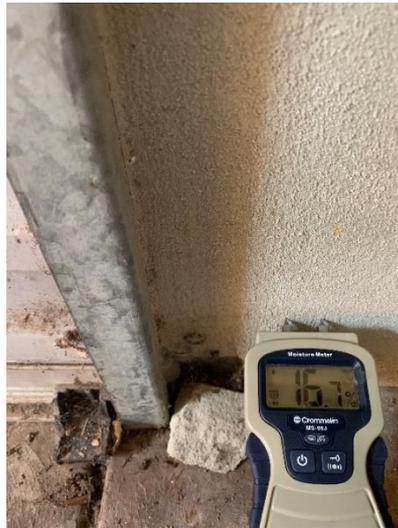
High moisture readings were measured in the wall between the two garage roller doors.

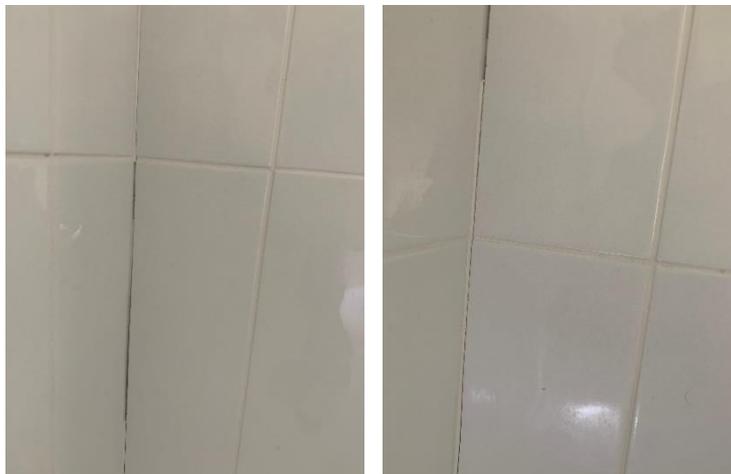
While no cracks were observed in the shower tiles, it was noted in the master ensuite shower that the grout is showing signs of deterioration. This will require maintenance in the short term to prevent water damage.

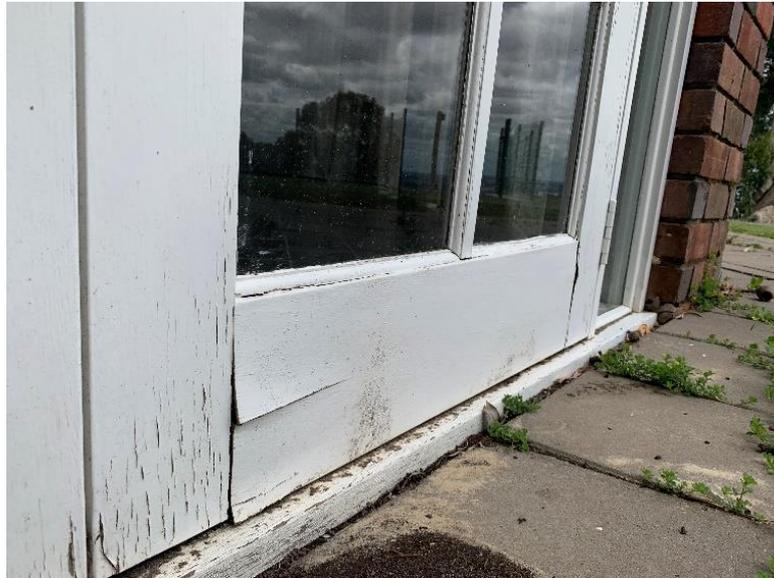
There is some visible water damage which is affecting the timber doors leading up to the backyard.

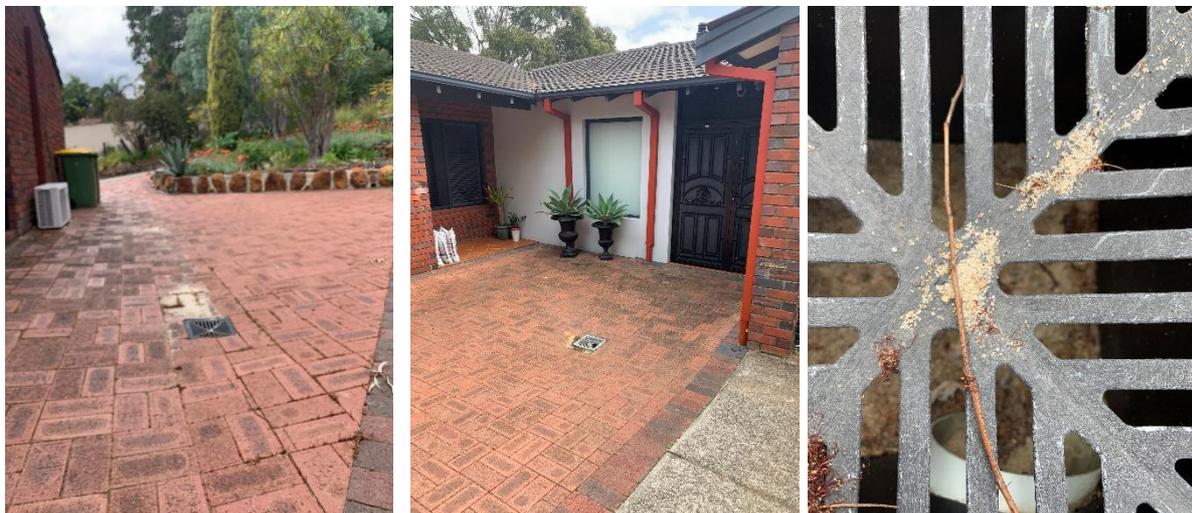
There is evidence that a subsoil drain exists along the front elevation. The presence of two soakwells and minor settlement in paving attributed to the digging of a trench supports our observation. However, upon inspection, it was not possible to determine where the water collected by this subsoil drain is discharged. Furthermore, the pits were found to be full of sand which is undesirable. It is important to ensure that subsoil drains are fully maintained and in working order (this will require maintenance in the short term).

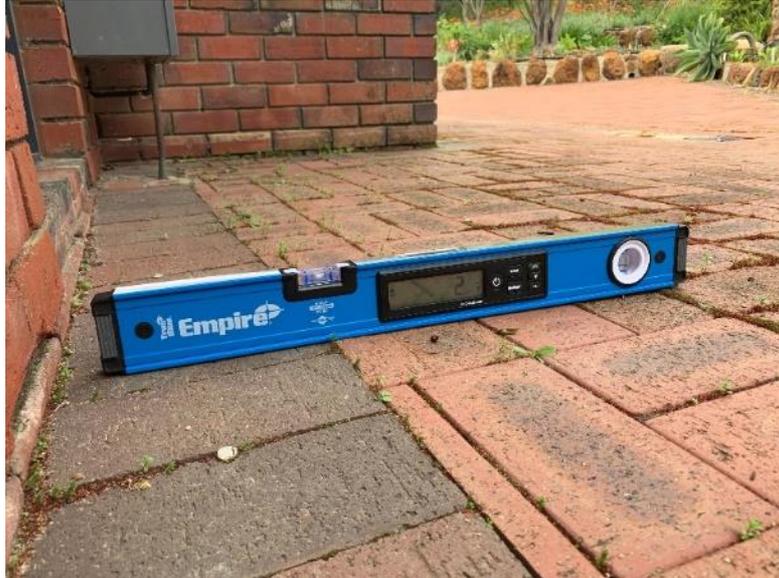
In the vicinity of the subsoil drain it was noted that the grade in the pavement is inadequate. The following image shows that the grade is 2mm/m and falls towards the foundation rather than directing water away from the building:

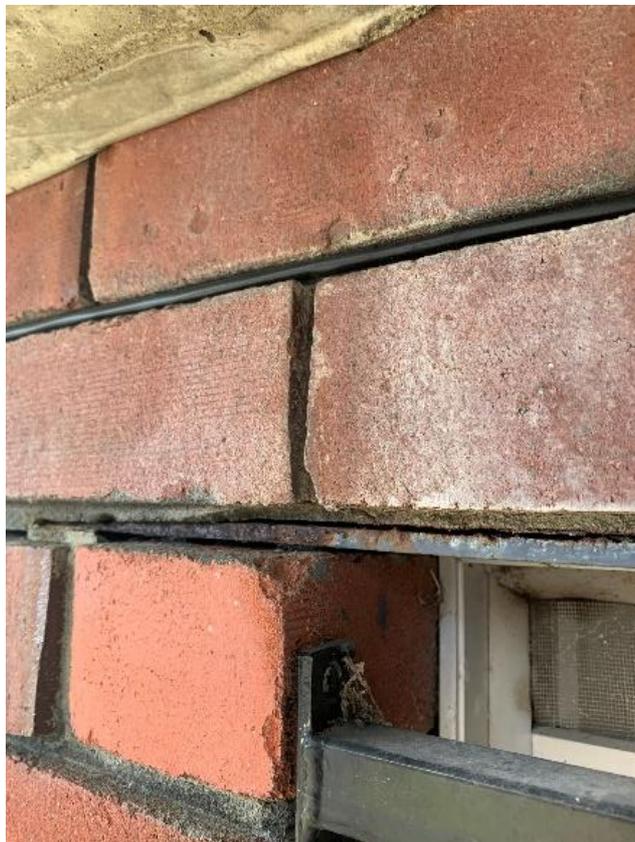
There is evidence of window lintel corrosion. The worst case was observed on the western elevation (window to toilet). Material deterioration such as corrosion needs to be addressed with ongoing maintenance. This particular example should be remediated as soon as possible (it will require the removal of brickwork and a new lintel installed).

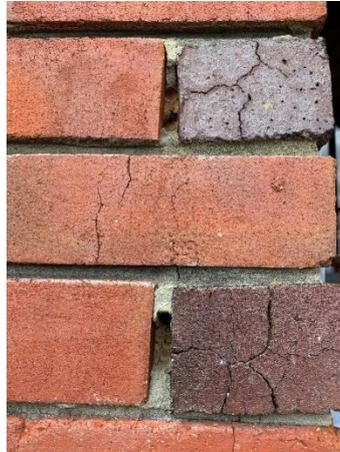
Mortar fretting and deterioration in mortar joints was also observed though the exterior of the main dwelling. This will require ongoing maintenance to prevent water penetration. Re-pointing should be undertaken in the short term.

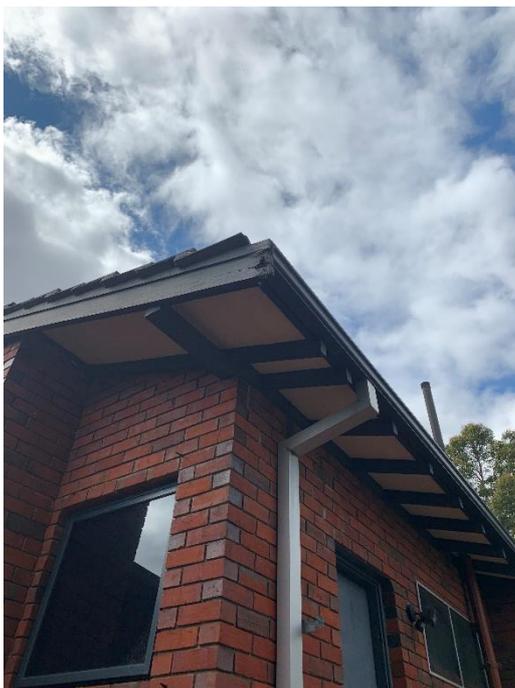
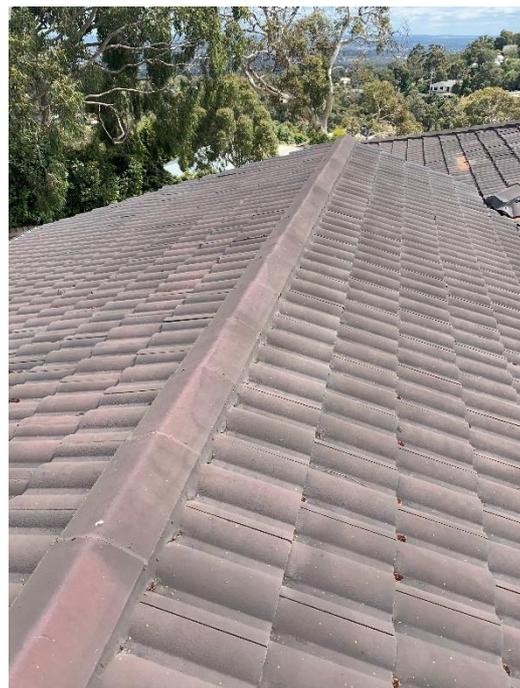
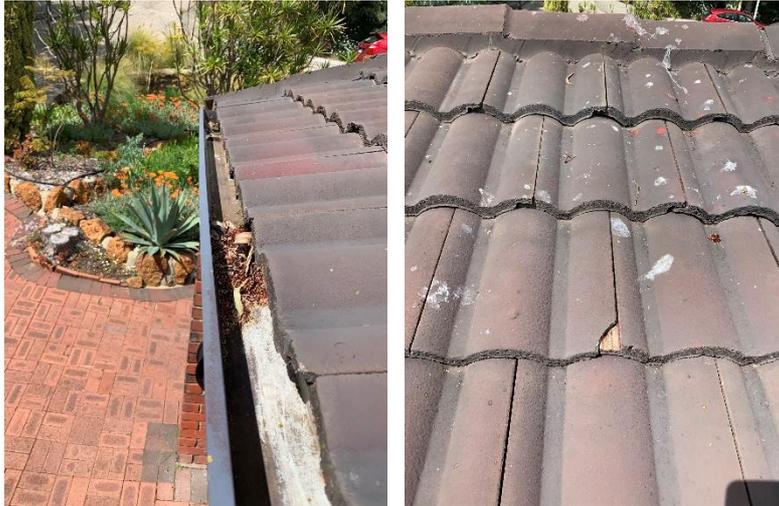
Overall the timber fascia is in very poor condition. Some maintenance is required in the short term to replace cracked tiles and to prevent water ingress.

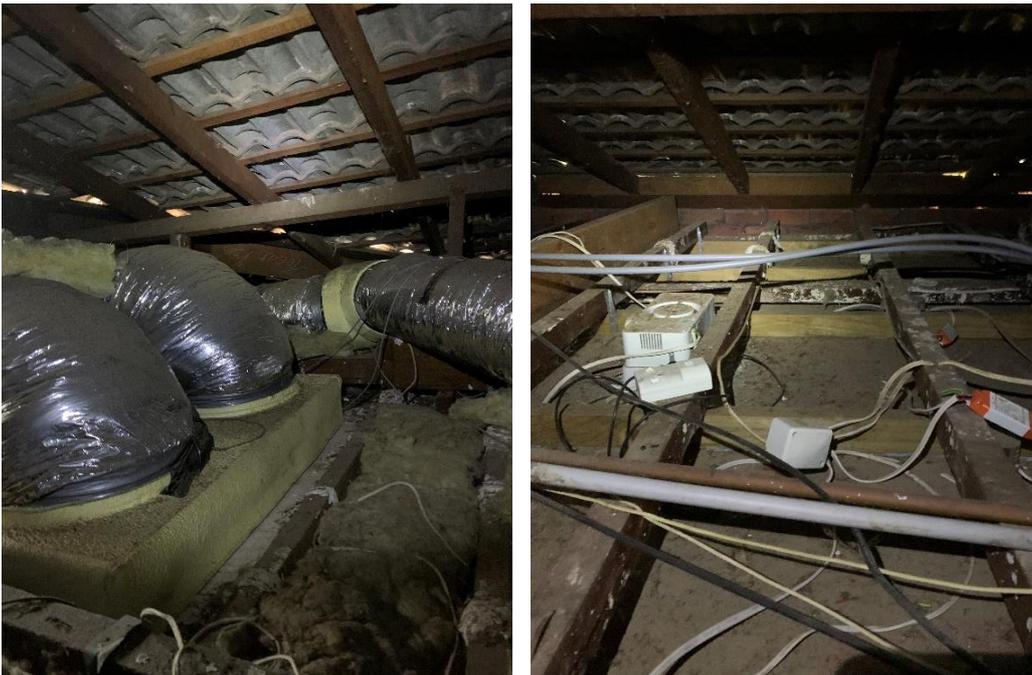
It was noted that insulation was not in place across the entire ceiling space. Concerns relating to wiring are highlighted in Safety Hazards.

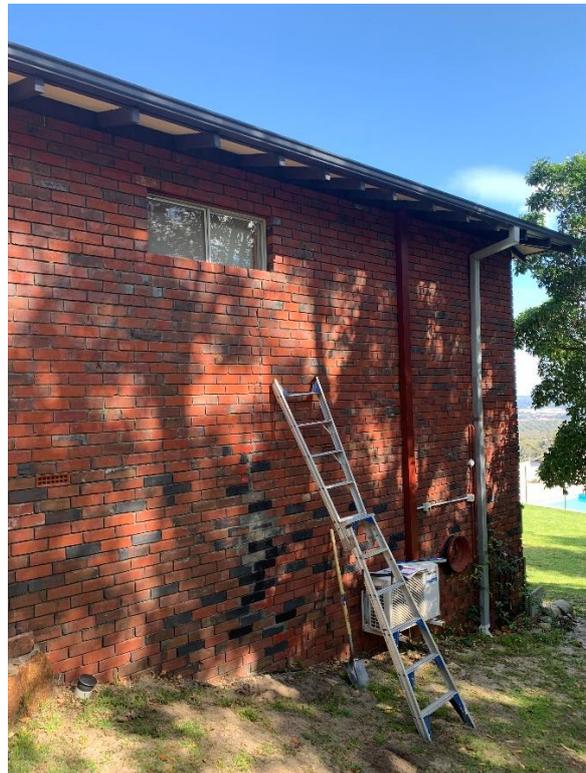
Image 1 - Eastern Elevation

It can be seen from the table above that the maximum deviation from plumb in the total height of the building is 25mm. The eastern elevation is experiencing cracking and movement which was measured using a calibrated electronic spirit level.

- It is recommended that registered builders are approached to provide budget estimates & methodology to rectify the leaning walls. This may require removal of bricks and partial demolition of wall sections.

- The addition of control or articulation joints is also recommended in accordance with the provisions of the National Construction Code (section 3.3.5.13). The services of a specialist geotechnical contractor should also be sought to discuss methods for underpinning using proprietary or pre-engineered products.

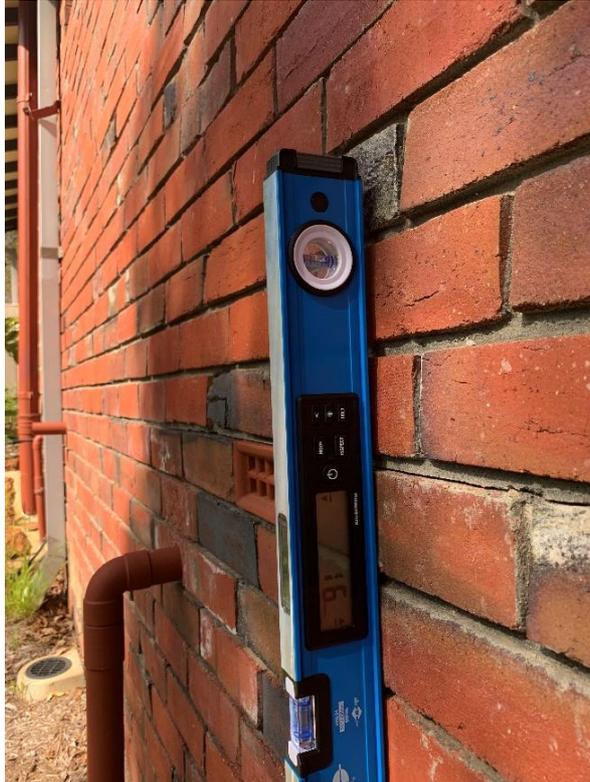
Image 2 - Deviation from verticality below slab of 16mm/m inwards

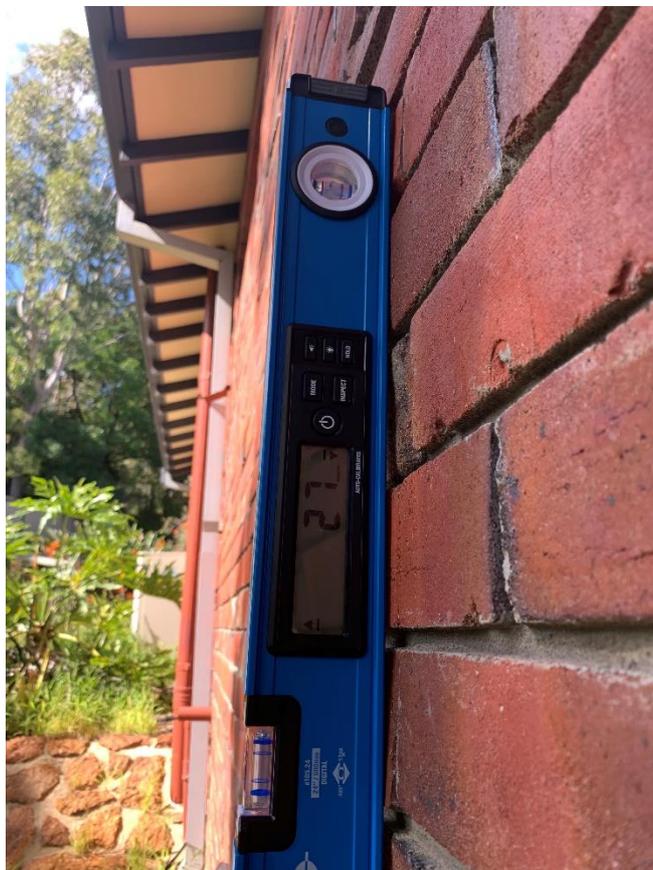
Image 3 - Deviation from verticality above concrete slab of 27mm/m inwards

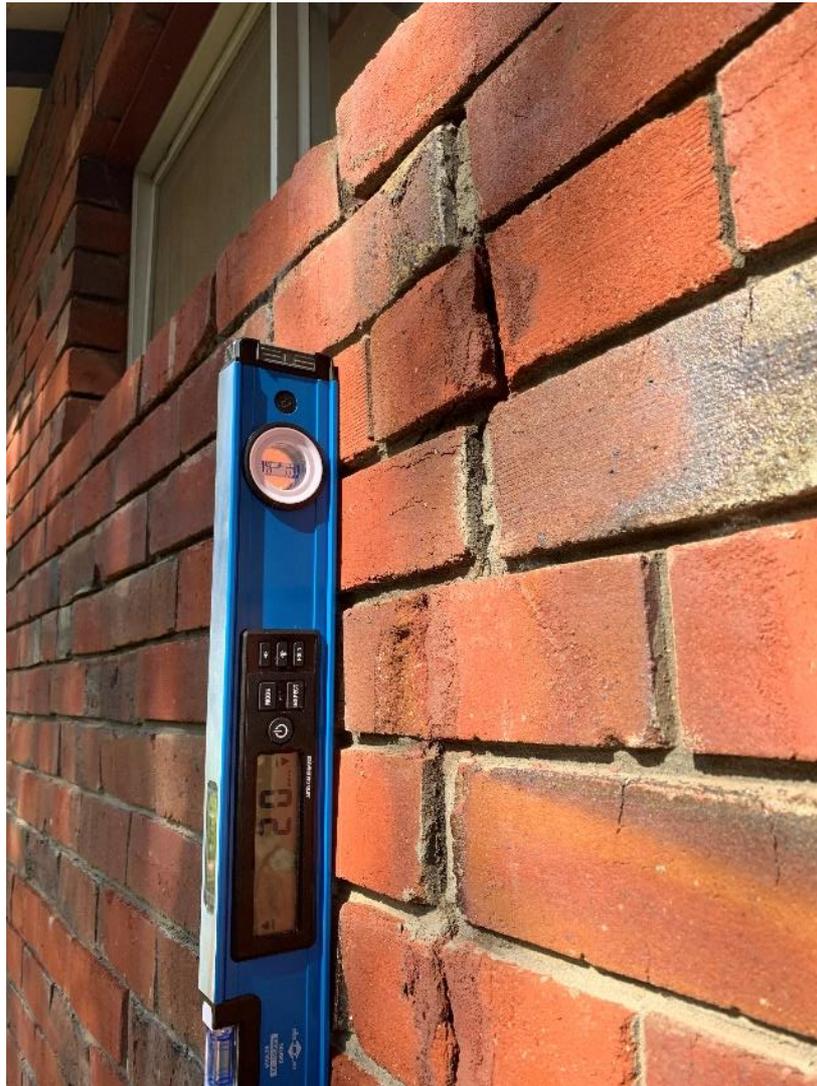
Image 4 - Deviation from verticality below window of 20mm/m inwards

The movement in the wall below the suspended concrete slab is outward while the movement in the wall above the suspended slab is inward. It is likely that the footings are experiencing a rotation due to soil movements while the roof is retaining the top of the walls, hence the inward movement. A distinctive crack in the mortar joint in line with the top of the weep holes (just above the suspended slab) can be seen externally.

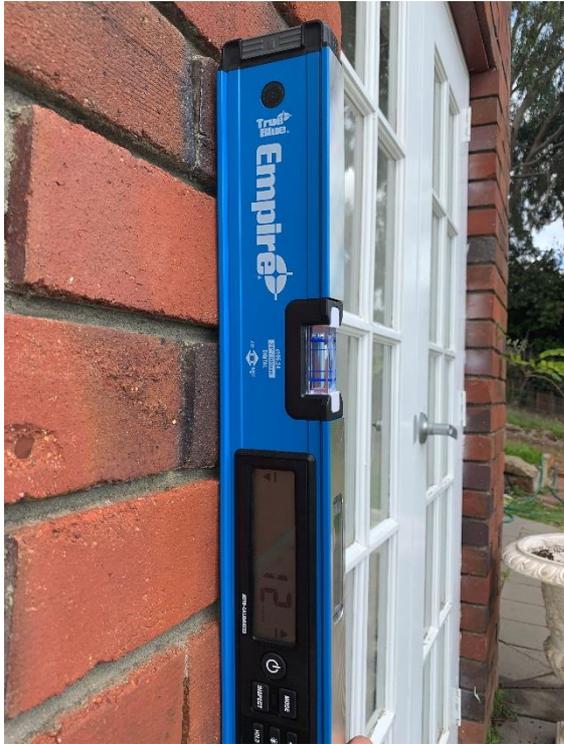
Image 5 - measurement along northern elevation

The measured deviation in verticality was measured at other locations on the eastern, northern and western elevations:

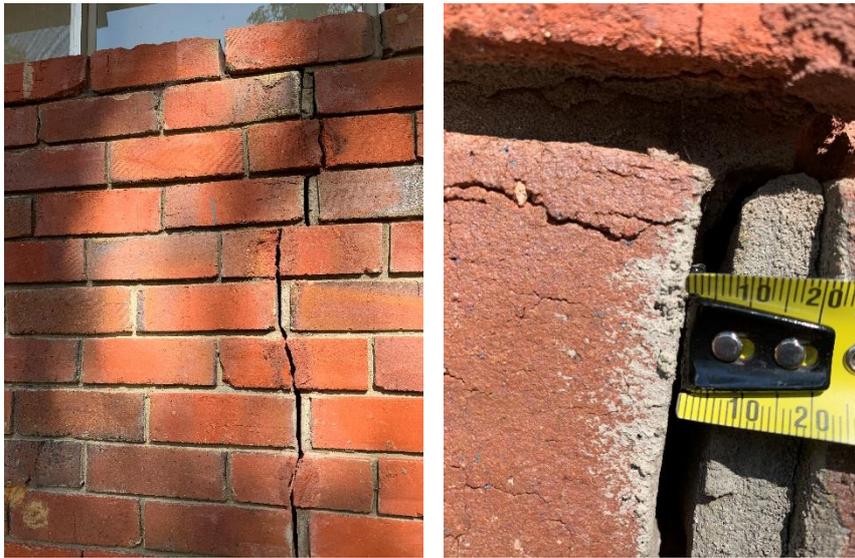
Cracking up to 8mm was observed in the external walls. The most significant cracking is present in the eastern elevation. It is likely that these cracks are caused by one or a combination of the following factors:

1. Inadequate soil compaction prior to construction of the dwelling;
2. Design, construction and/or settlement in the concrete foundation;
3. Shrinkage in the suspended concrete slab;
4. Trees altering the moisture conditions over time;
5. Expansive and shrinkage movement in the reactive soil.

It is recommended that cracks are sealed with a flexible sealant or a polyurethane sealant which is colour matched to preserve the aesthetics & to prevent moisture penetration. Crack development should be monitored and structural repairs to the footing system such as deep underpinning should be considered if cracking in excess of 2mm re-appears.

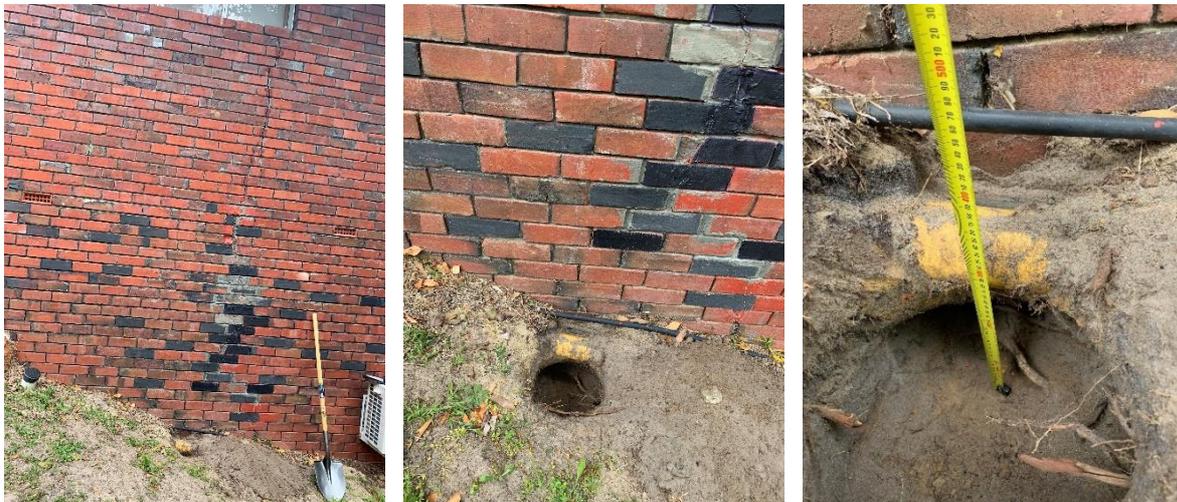
Hand excavation was undertaken to confirm the footing depth. A pit was dug to approximately 400mm after which very hard and dry clay was uncovered. Presence of rocks and rouble as well as tree roots was also found. Hand excavation could not penetrate further than 400mm.

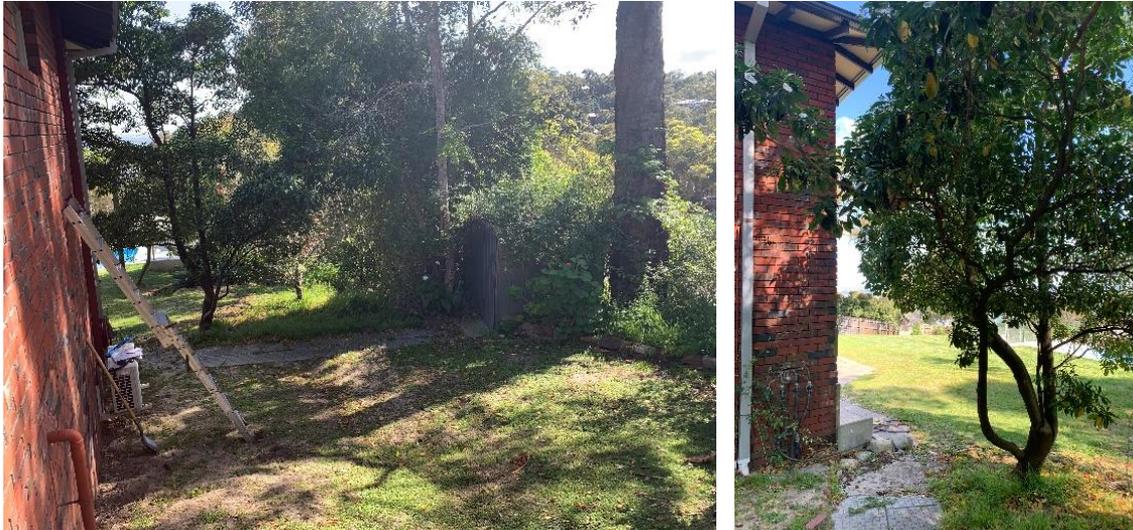
A large tree approximately 800mm in diameter and greater than 20m in height is located approximately 7.7m from the eastern wall. Available literature suggests that the tree roots can extend anywhere from 0.4 to 2.0 x the height of a tree which could cause foundation issues.

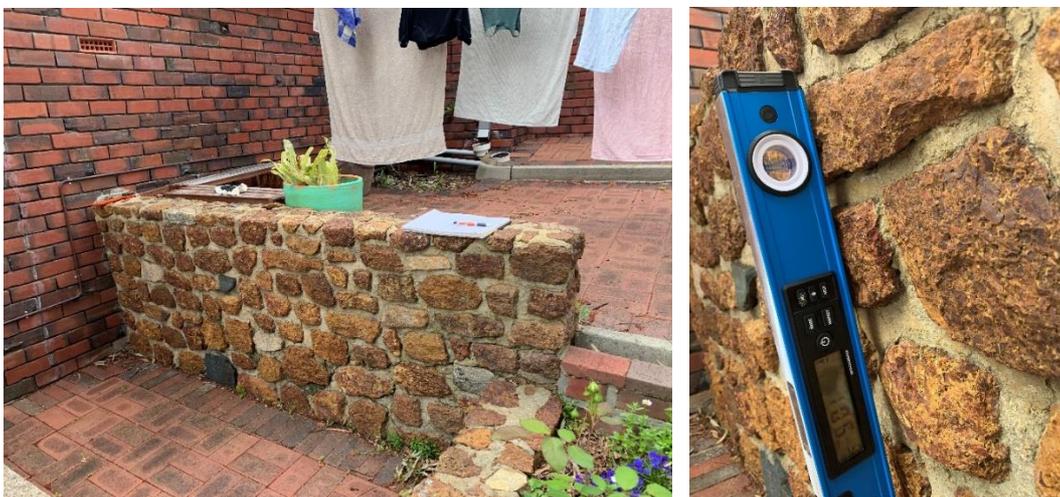
A retaining wall is currently located on the western side, near the clothes line. This retaining wall was measured to be approximately 940mm high. The wall is leaning approximately 106mm/m which exceeds allowable tolerance (20mm/m maximum)

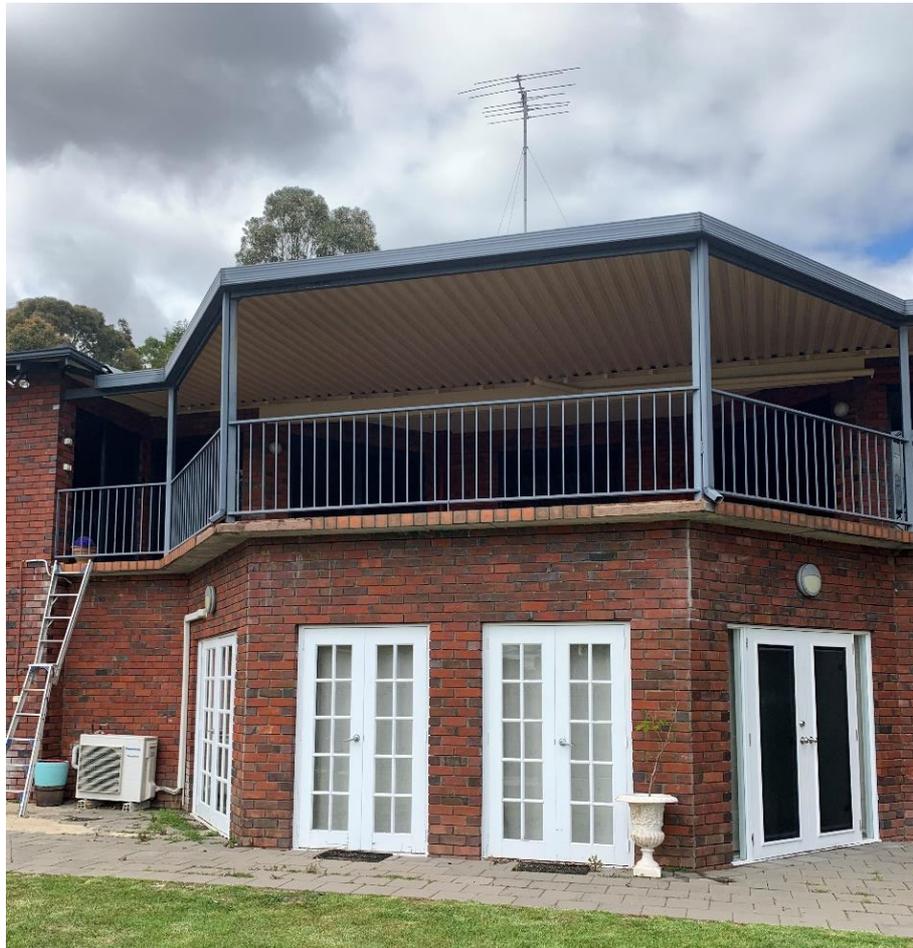
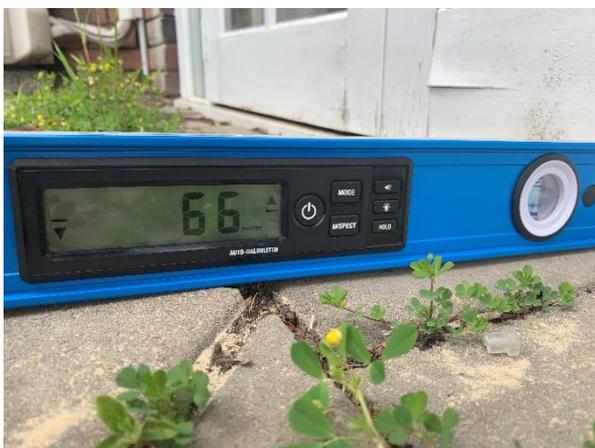
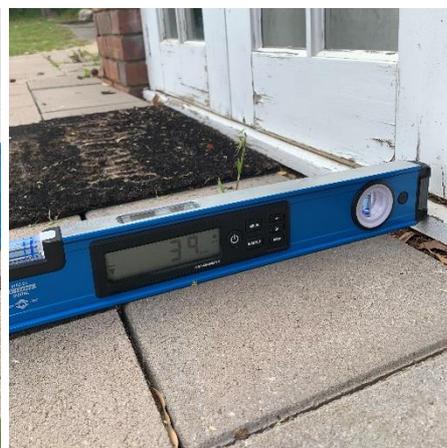
The paving outside the undercroft room at the rear of the dwelling is directing water towards the foundation. This is problematic because the two downpipes from the balcony are making the situation worse. Considering the observed movement and cracking in the building, this is a major defect that needs to be rectified urgently.

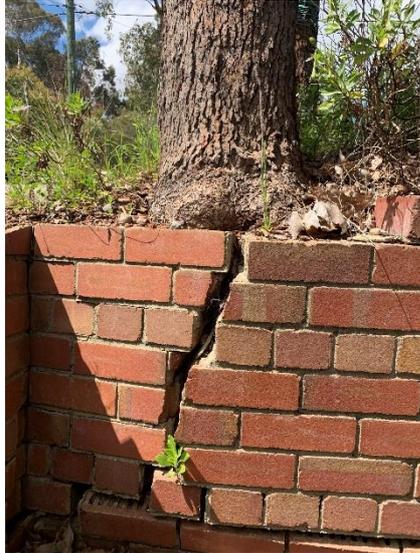
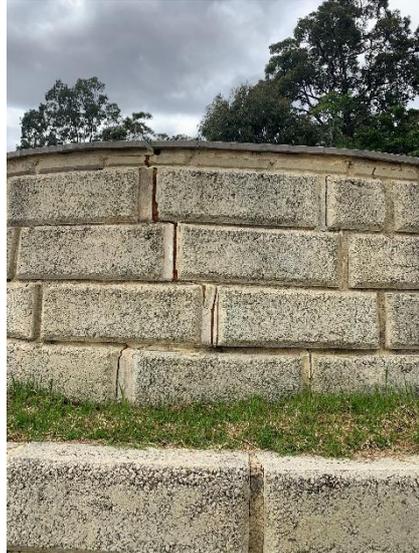
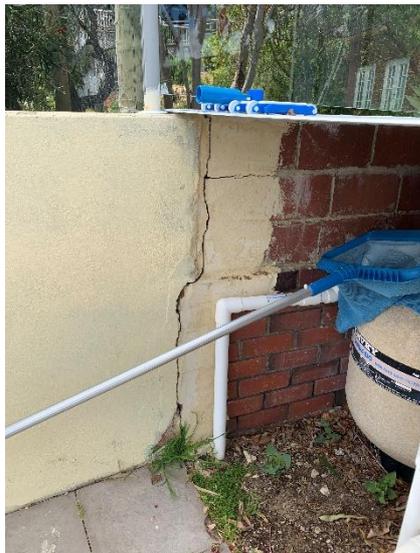
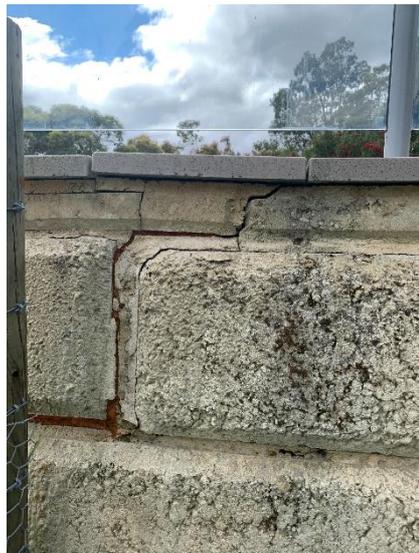
There are other retaining and screen walls which were found to be defective that will require maintenance in the short to medium term.

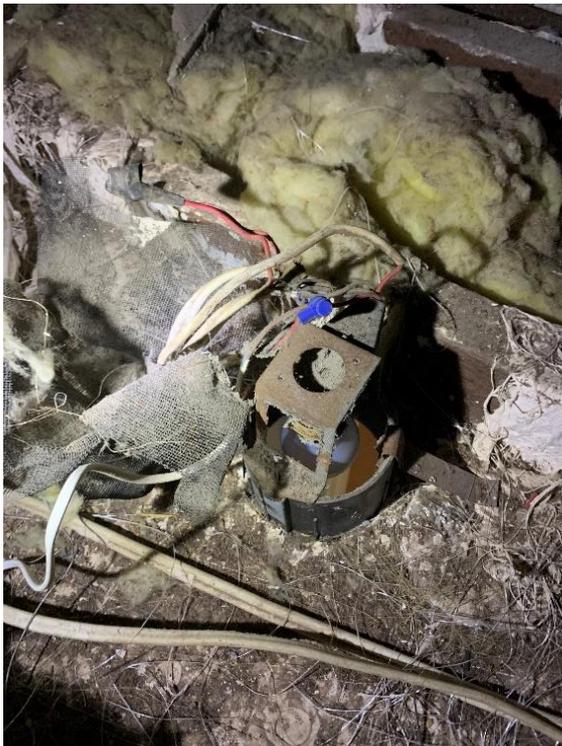
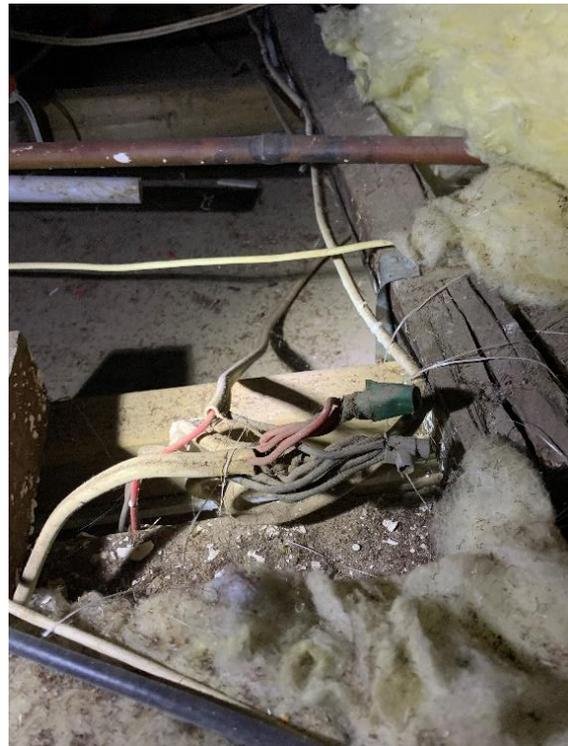
Several wiring connections in the roof space are not adequately protected by a junction box. This is an installation defect. Junction boxes provide a second insulation barrier to adequately seal off and protect the wires, increasing the safety of the immediate environment and ensuring that the wiring is not damaged.

The absence of junction boxes in the roof space poses as an electrical safety hazard, providing risk of electrocution. Appointment of a licensed electrician is highly advised to provide additional information on the risks of unprotected wiring and to install junction boxes and any other elements as required.

Such works should be carried out as a matter of urgency; until this time, any persons within the roof space should exercise a high level of caution.

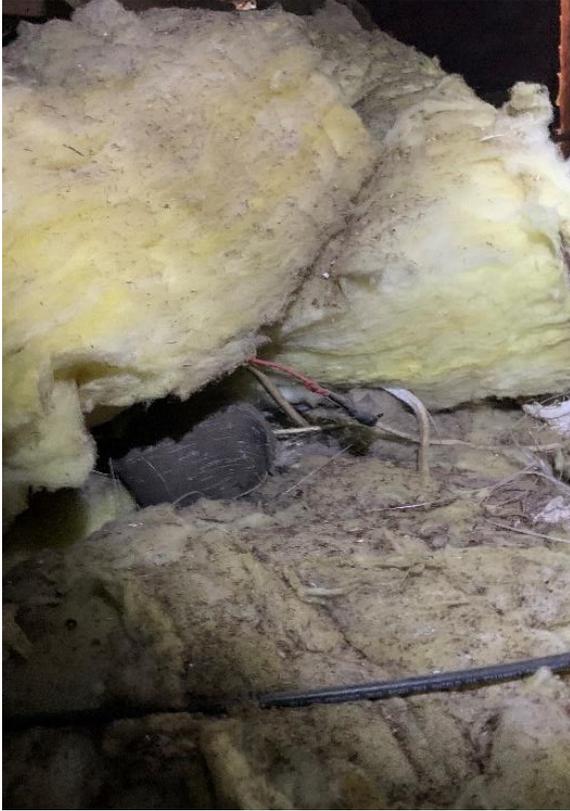
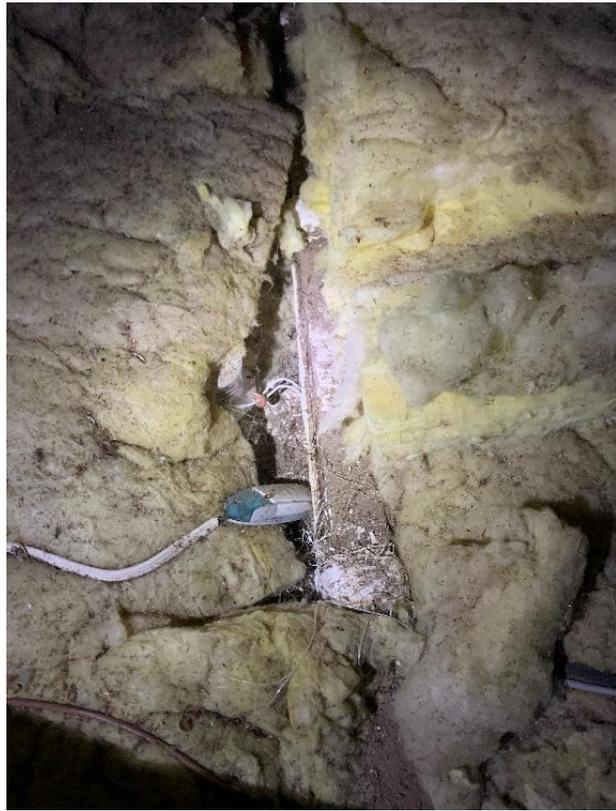
Recessed luminaires such as downlights and their auxiliary equipment (such as transformers) need to be installed in a manner designed to minimise temperature rise and prevent the risk of fire. We recommend that a licenced electrician is appointed to inspect the roof space and certify that all wiring connections, downlights and transformers are correctly installed and have enough clearance to insulation.

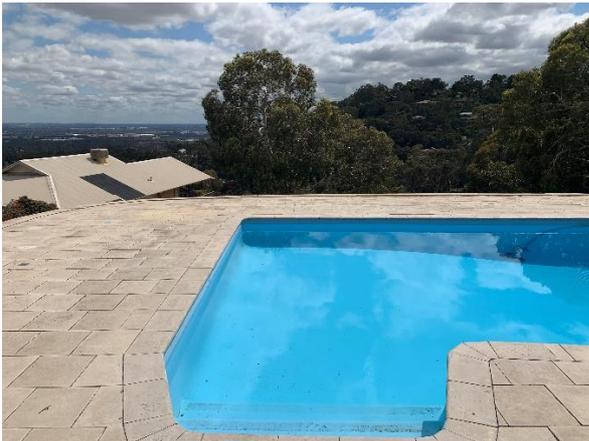
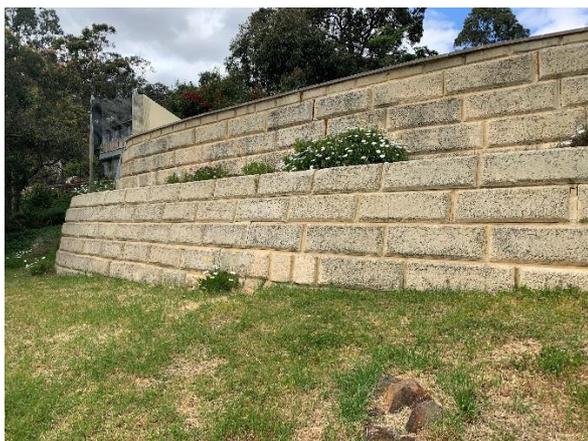
The swimming pool area does not have adequate fencing or balustrading to prevent falls. We recommend that adequate facing or balustrading is installed to meet the requirements of section 3.9.2.3 of the National Construction Code (2019 edition).

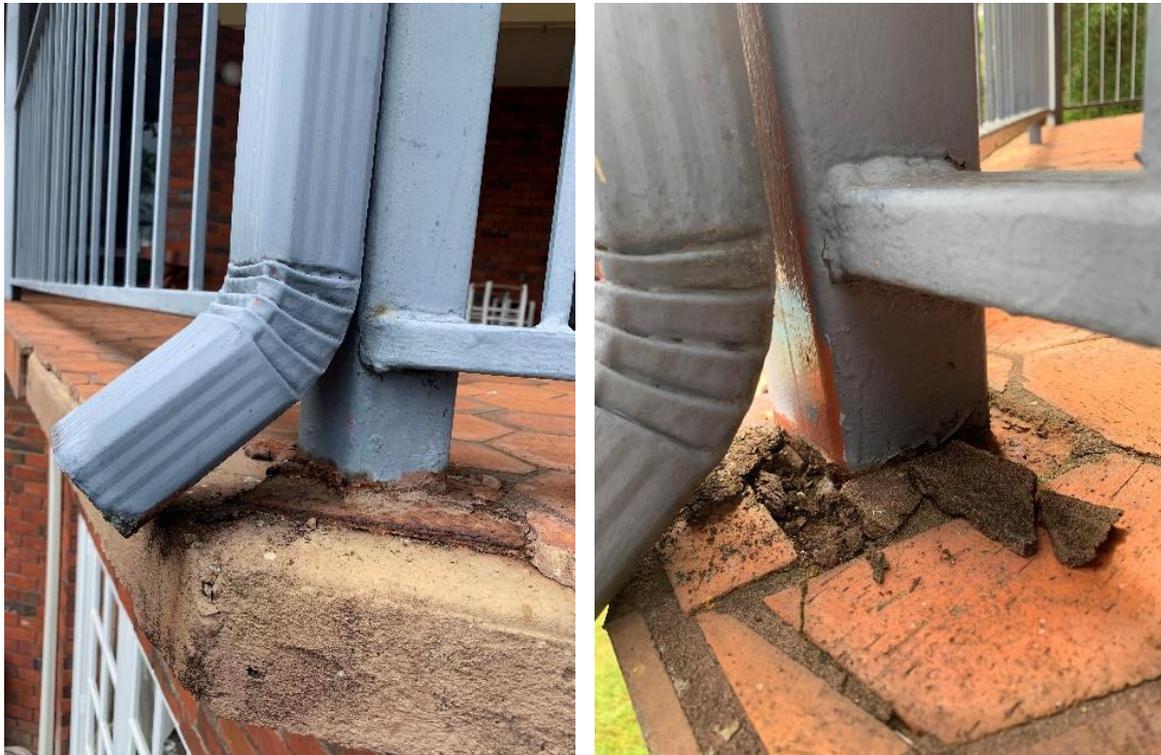
There is evidence of advanced corrosion in the posts supporting the balcony balustrade. It is recommended that this is urgently remediated. It is likely that sections of the balustrade will need replacement.

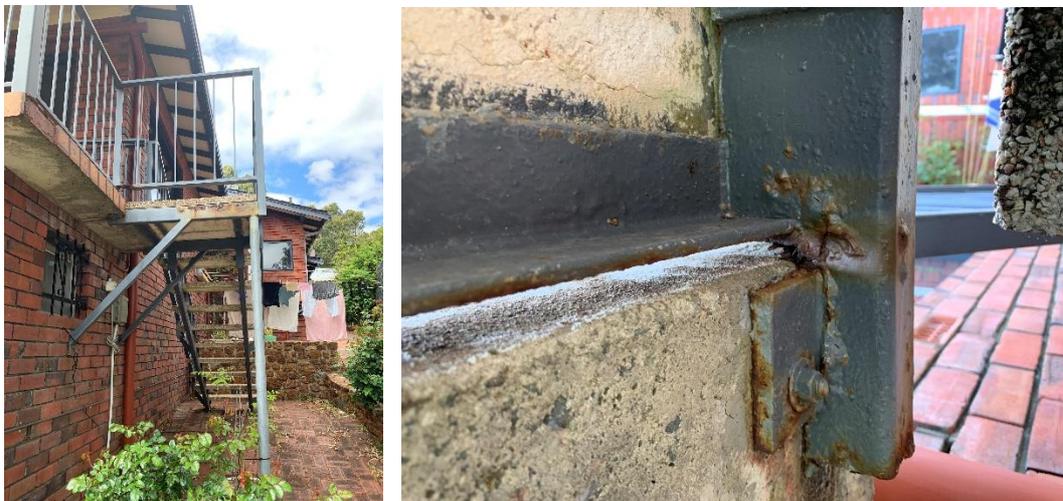
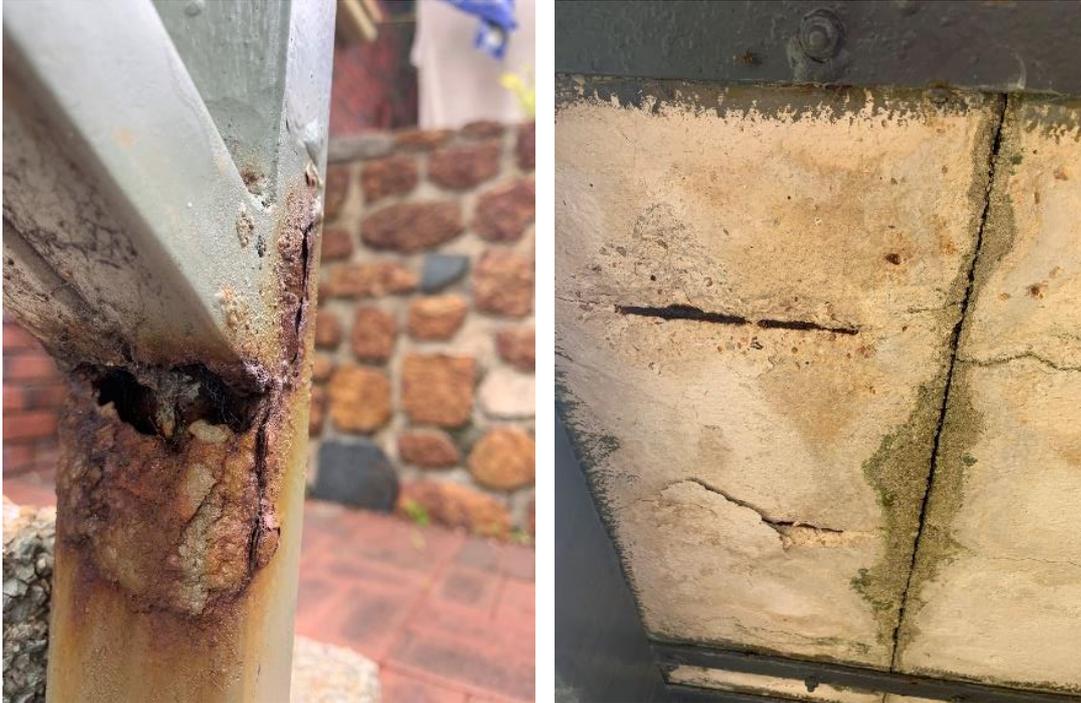
There is evidence of advanced corrosion in access staircase to balcony. The reinforcement in the precast concrete steps has also corroded.

Recommendation: replace the staircase as a matter of urgency.

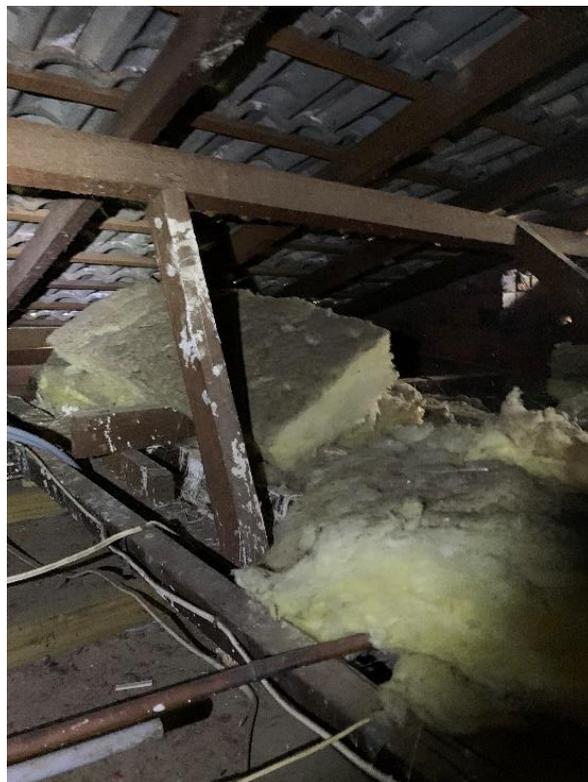
It was noted that battens of insulation were stacked on top of each other. This will most likely overload the ceilings and can result in collapse of the ceiling(s). We recommend that this stacked insulation is removed as soon as possible before settlement.
